SACRAMENTO RIVER FLOOD CONTROL SYSTEM EVALUATION

Initial Appraisal Report – Lower Sacramento Area

**US Army Corps
of Engineers**

October 1993

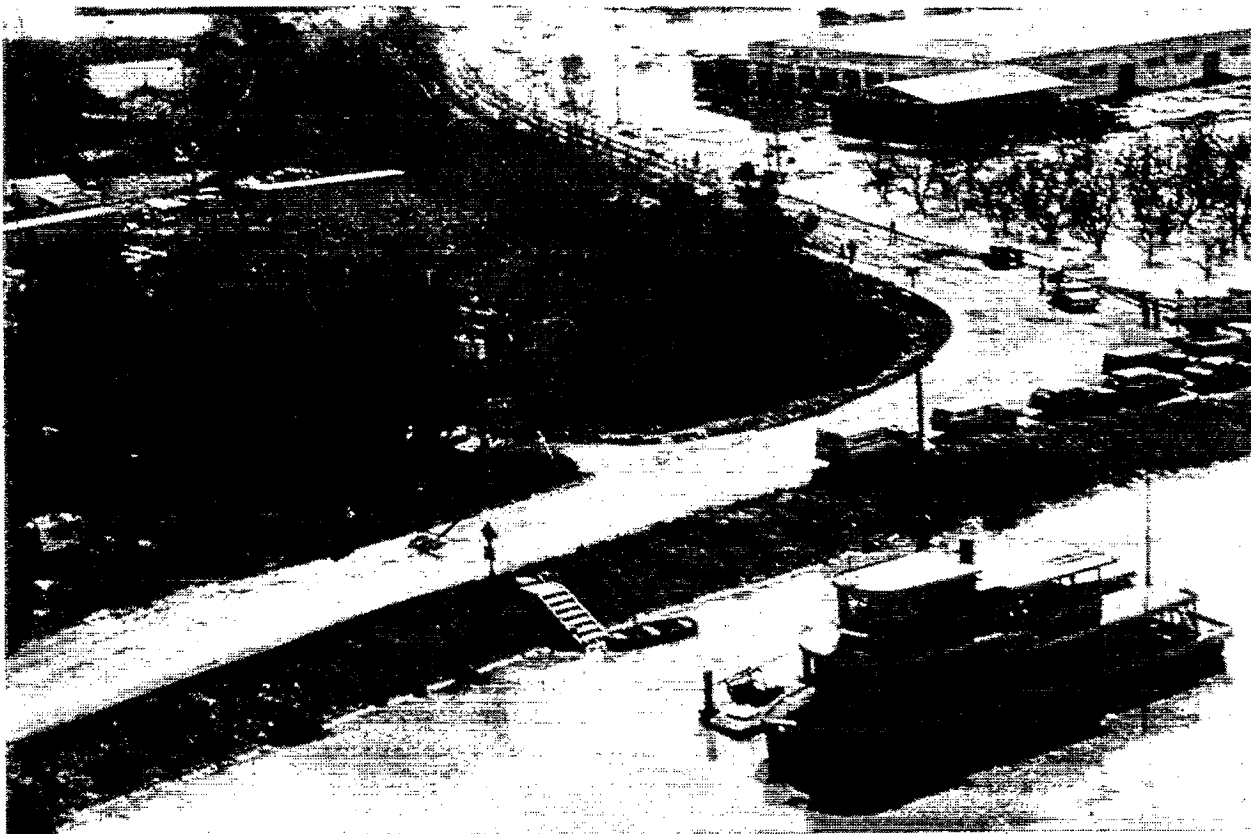
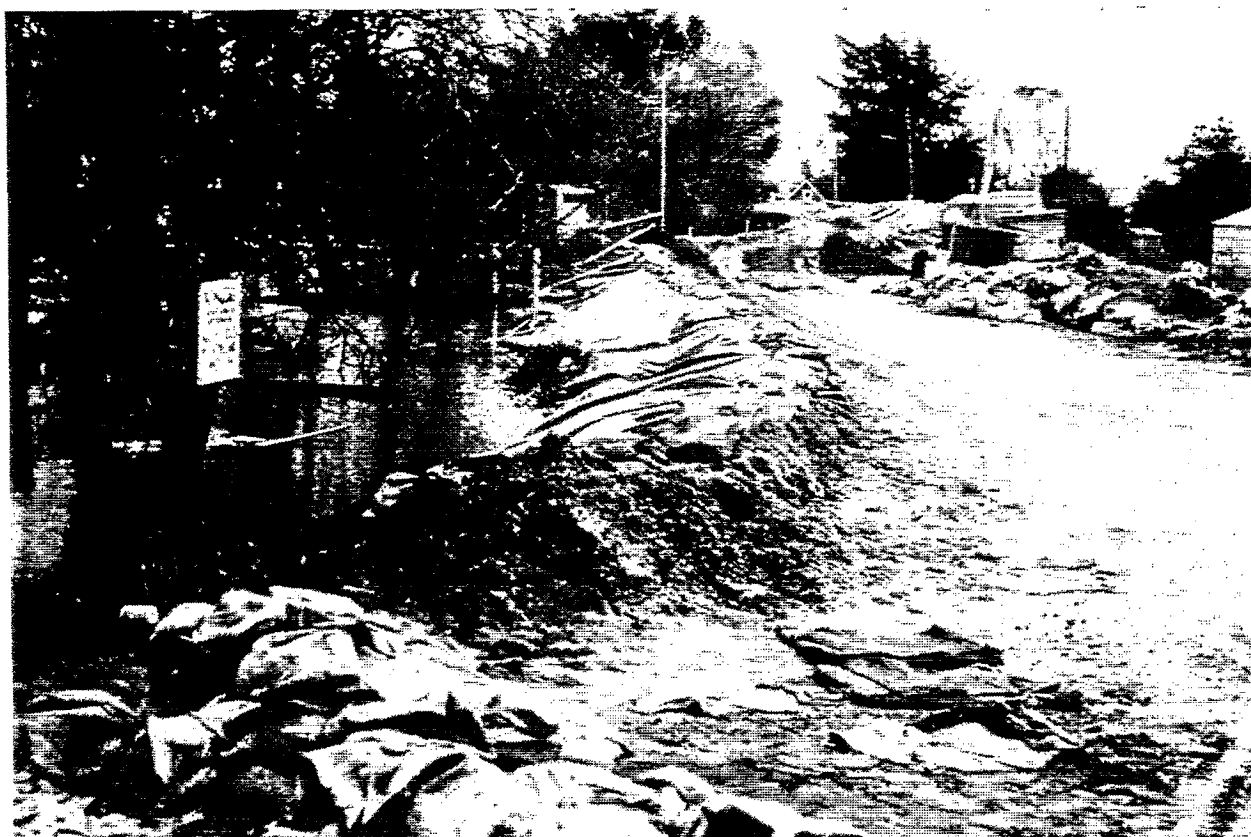
FIGURE 1

**FLOODING SOUTH OF WALNUT GROVE DURING FEBRUARY 1986 FLOOD
FROM NON-PROJECT LEVEE BREAKS**

At 3 a.m. on 19 February 1986, a non-project levee failed at two 300-foot-long sites on the Mokelumne River, causing flooding to most of Tyler Island (RD 563). The city of Walnut Grove, located on the Sacramento River at the north end of Tyler Island (RD 554), was threatened by flooding; 300 people were forced to evacuate. A Department of Water Resources (DWR) command center was set up at Walnut Grove to direct the flood fight, and up to 30 work crews from the Conservation Corps and Division of Forestry assisted. Two Forestry helicopters were used in the flood fight and removal of injured or stranded flood victims. At 5:00 a.m. on the 19th, the Corps of Engineers awarded a contract to build a 2,300-foot-long, 8-foot-high temporary levee to prevent flooding of the residential sections of Walnut Grove (see Figure 1). Fill material placed on the crown of the levee road prevented overtopping by floodwaters, at a cost of \$267,000. Total flood damages to Tyler Island were approximately \$10.4 million (1986 dollars).

To prevent levee failure and flooding in the city of Isleton, the Corps on 19 to 21 February placed sand material along 300 feet of non-Federal levee for Brannan-Andrus Island at a cost of \$175,000. Sand was placed at a second 800-foot-long site between 22 February and 7 March, at a cost of \$128,000.

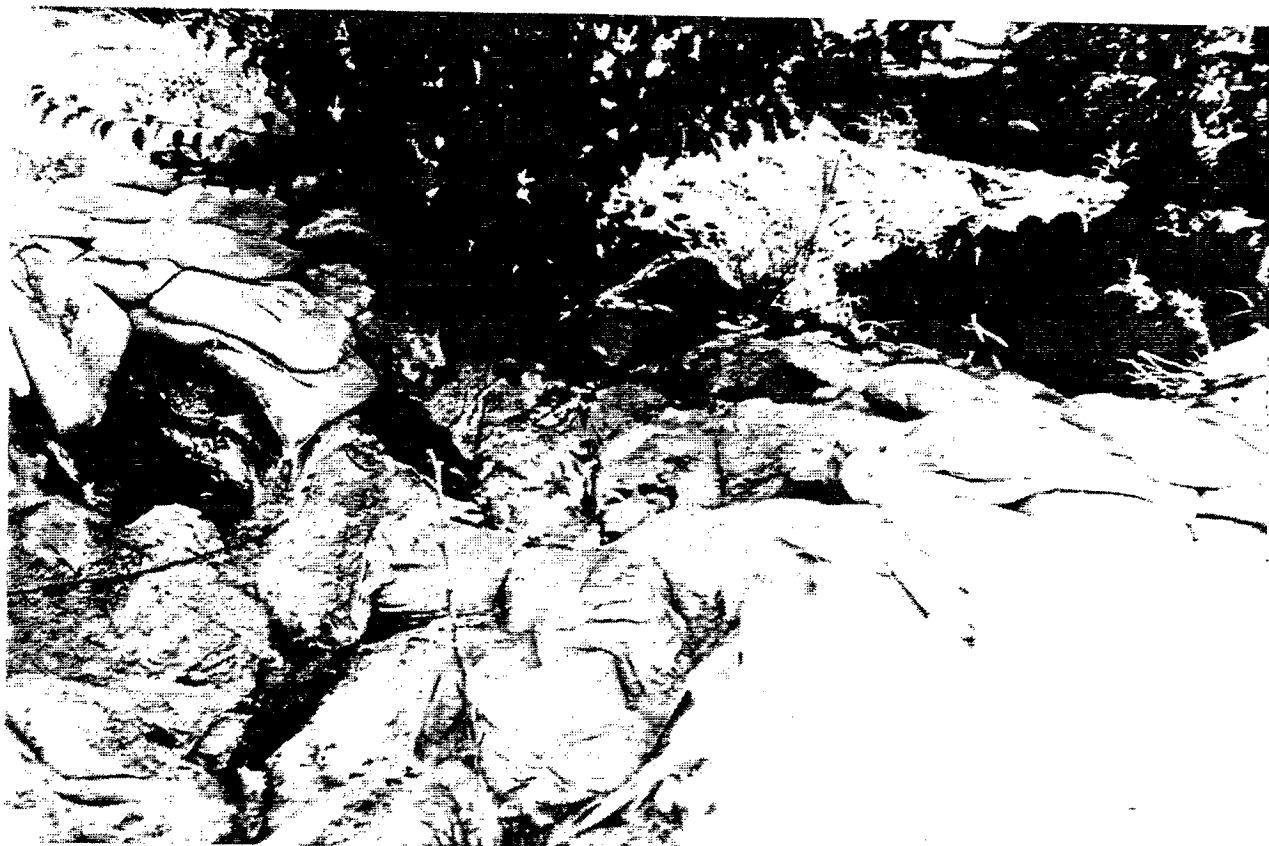
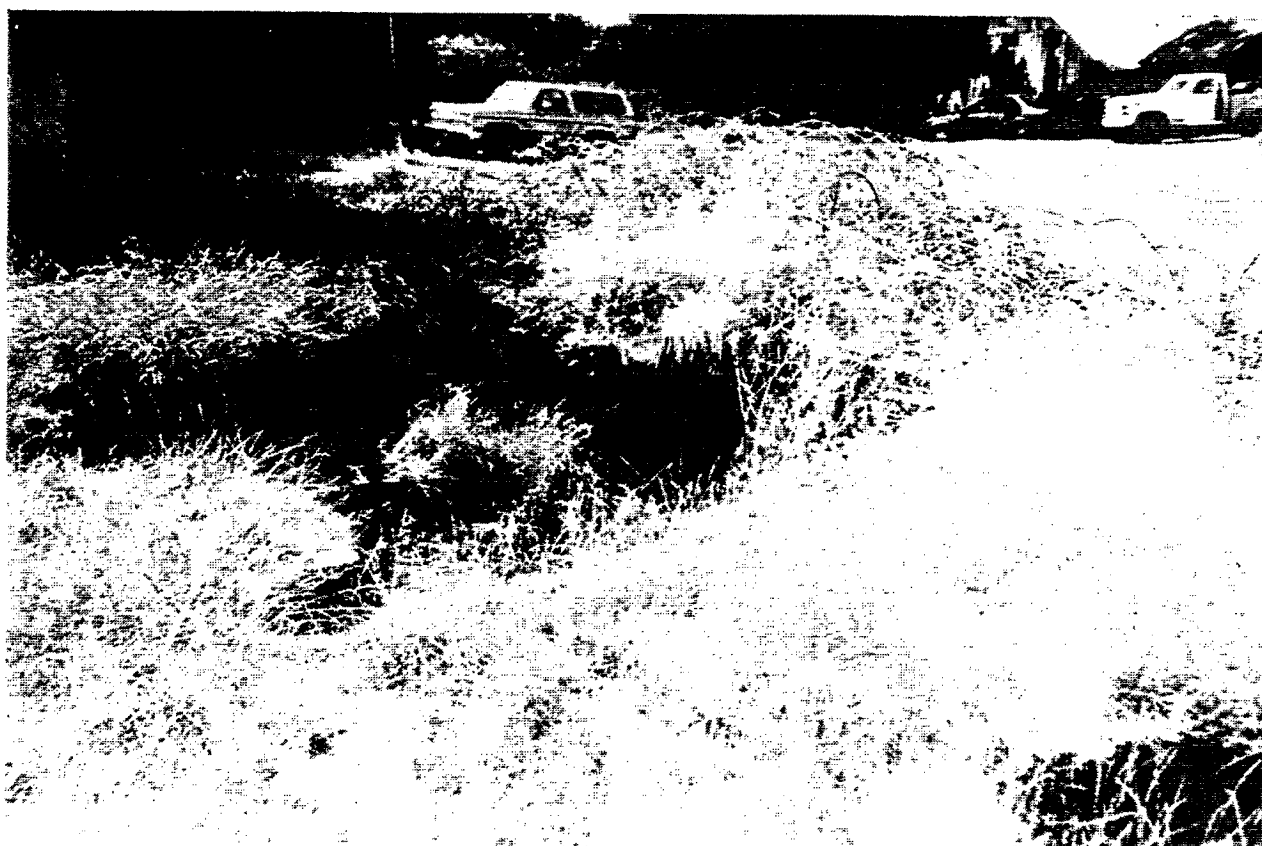
FIGURE 2

150, 556, and 755, as shown on the front cover and Figures 2 and 3. The sandbagged boils shown on Figures 2 and 3 discharged significant amounts of sandy material. In addition, a sinkhole was observed in the vicinity of the boil shown in Figure 3. Several boils were sandbagged to heights ranging from 4 feet to 6 feet (see front cover). There is also a seepage area about 3 miles long adjacent to the levee embankment near the southern limit of Reclamation District 3. At the lower limit of the project levee system, landside levee embankment slope failures are a continual problem. The slope failures result in levee crown and embankment subsidence (see Figure 4), flatter landside levee slopes, and a broader levee embankment base. The county road was moved from the levee crown in this area several years ago to avoid the continual road maintenance associated with these slope failures. Some of the slope failure repairs have included a landside berm about 50 feet wide at the landward toe of the levee to minimize the potential for future slope failures.

**SANDBAGGING OF BOILS DURING FEBRUARY 1986 FLOOD
NEAR SACRAMENTO RIVER PROJECT LEVEE IN R.D. 556**

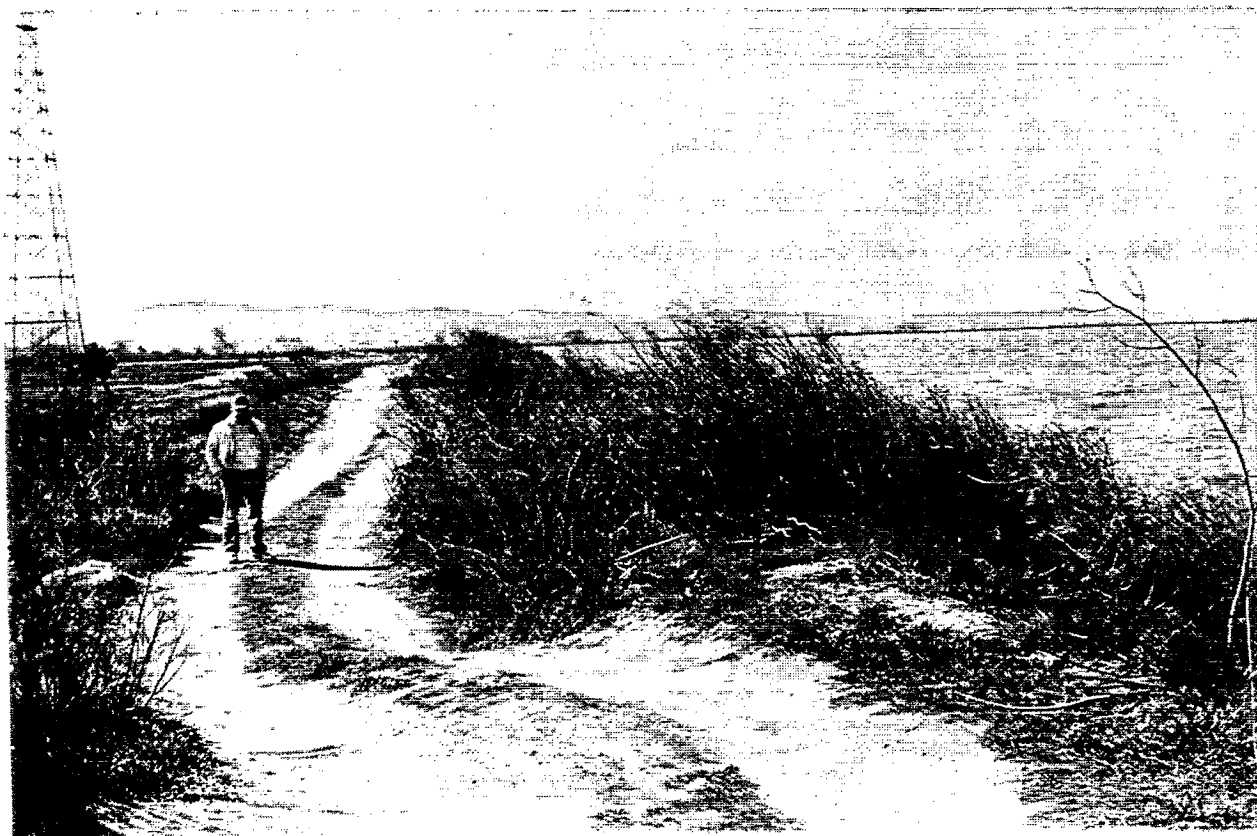
FIGURE 3

**BOIL AND SINKHOLE RESULTING FROM FEBRUARY 1986 FLOOD
NEAR SACRAMENTO RIVER PROJECT LEVEE IN R.D. 150**

Potential problems also result from seepage water moving through permeable levee foundation soils. If the energy of the seepage water is great enough, boils (Figure 3) and piping can occur landward of the levee embankment. Seepage evaluations

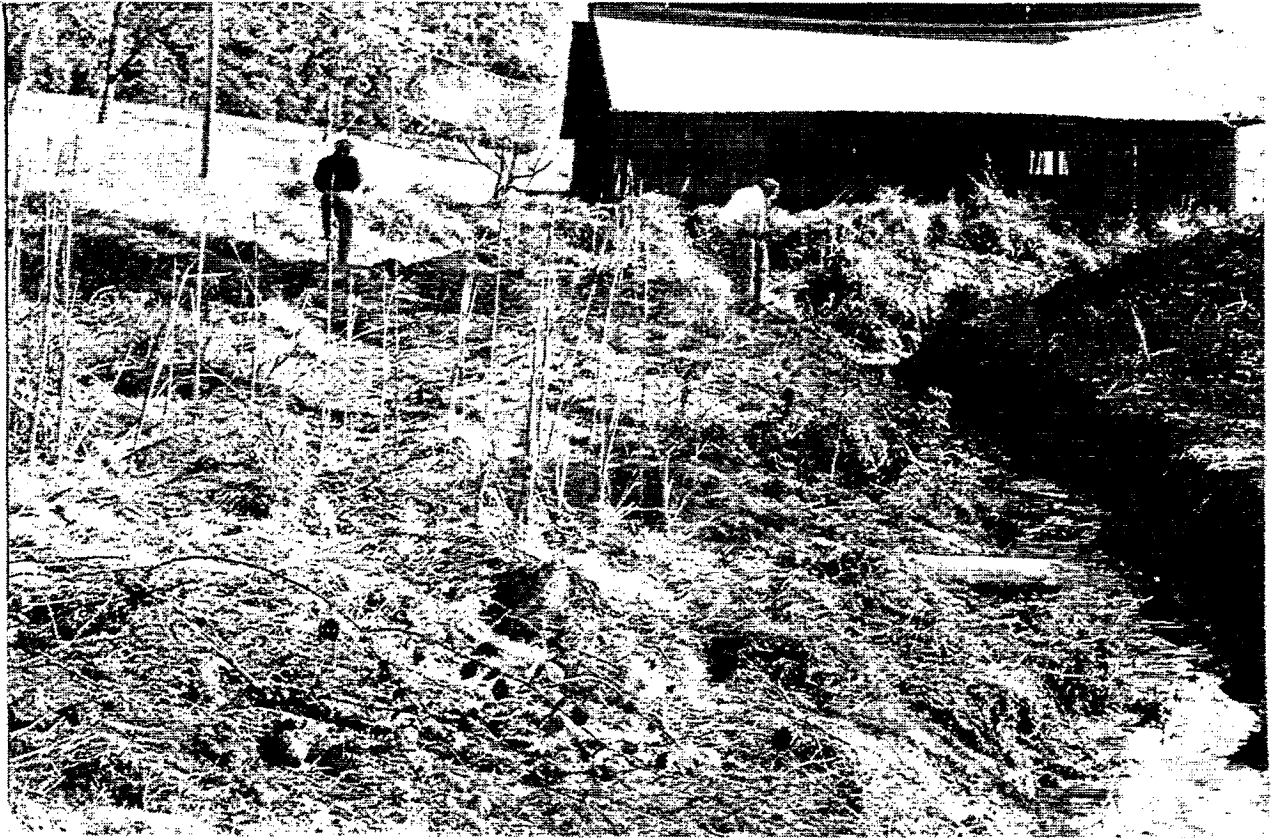
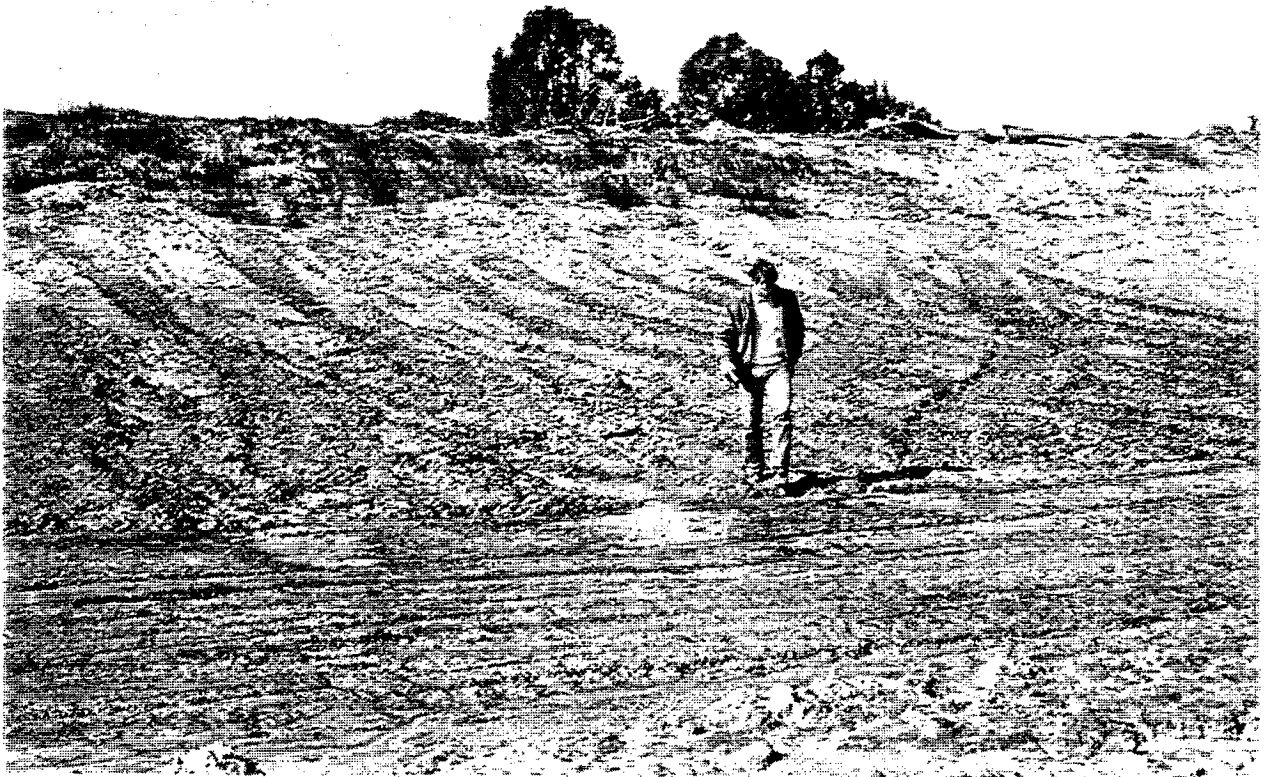
FIGURE 4

**LEVEE EMBANKMENT SUBSIDENCE
SACRAMENTO RIVER PROJECT LEVEE IN R.D. 341**

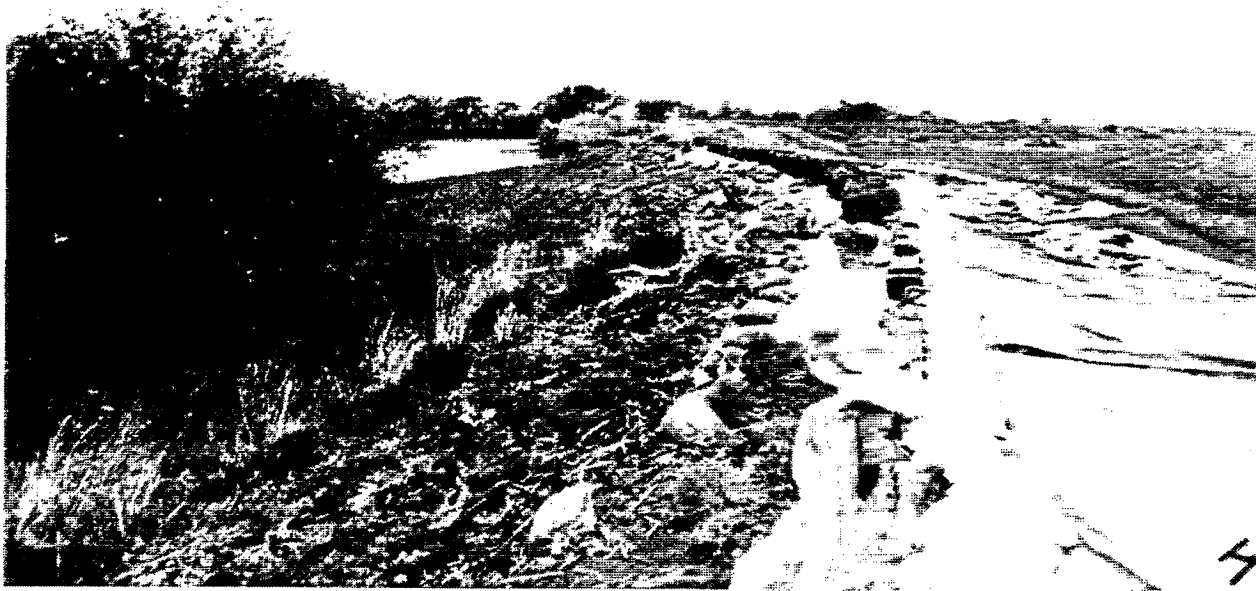
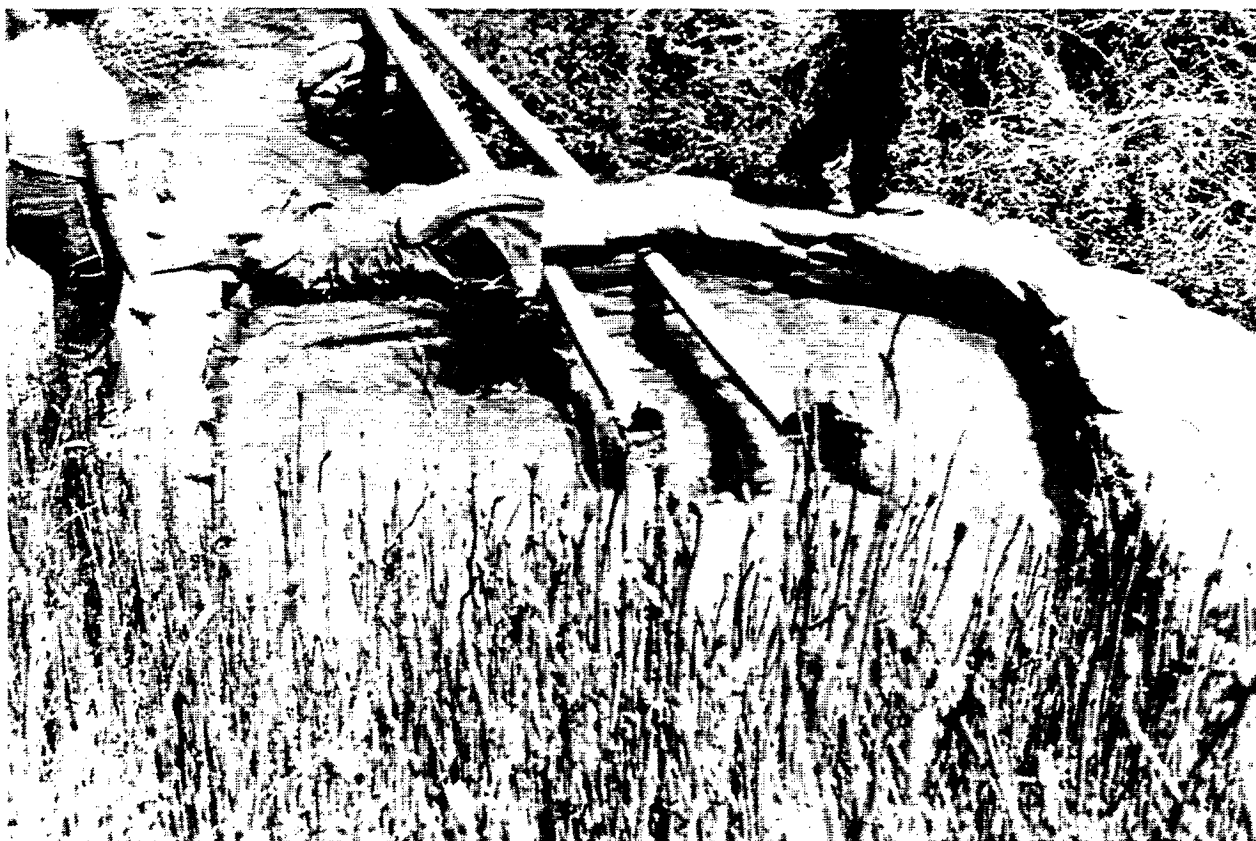
FIGURE 5

SEEPAGE WATERS VISIBLE ON LANDWARD SIDE OF LEVEE
DURING NORMAL RIVER FLOWS

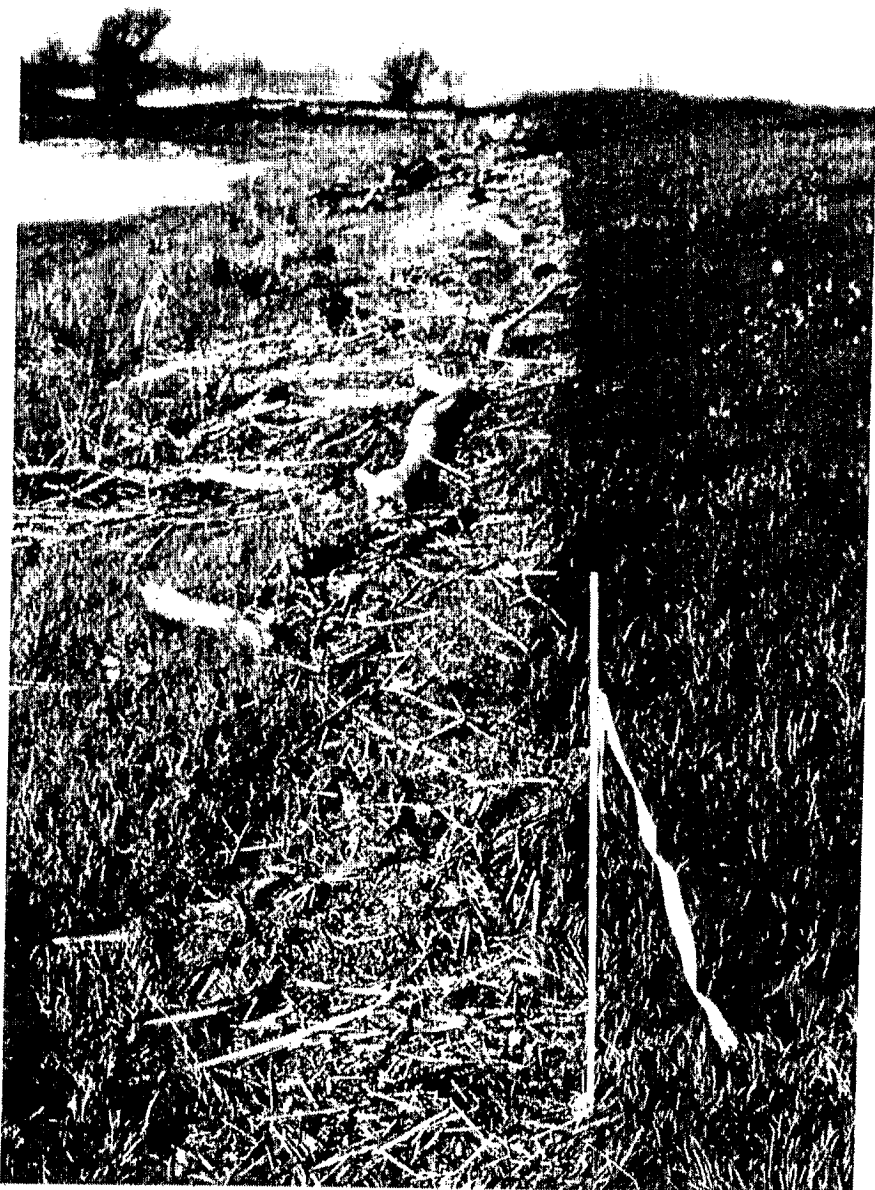
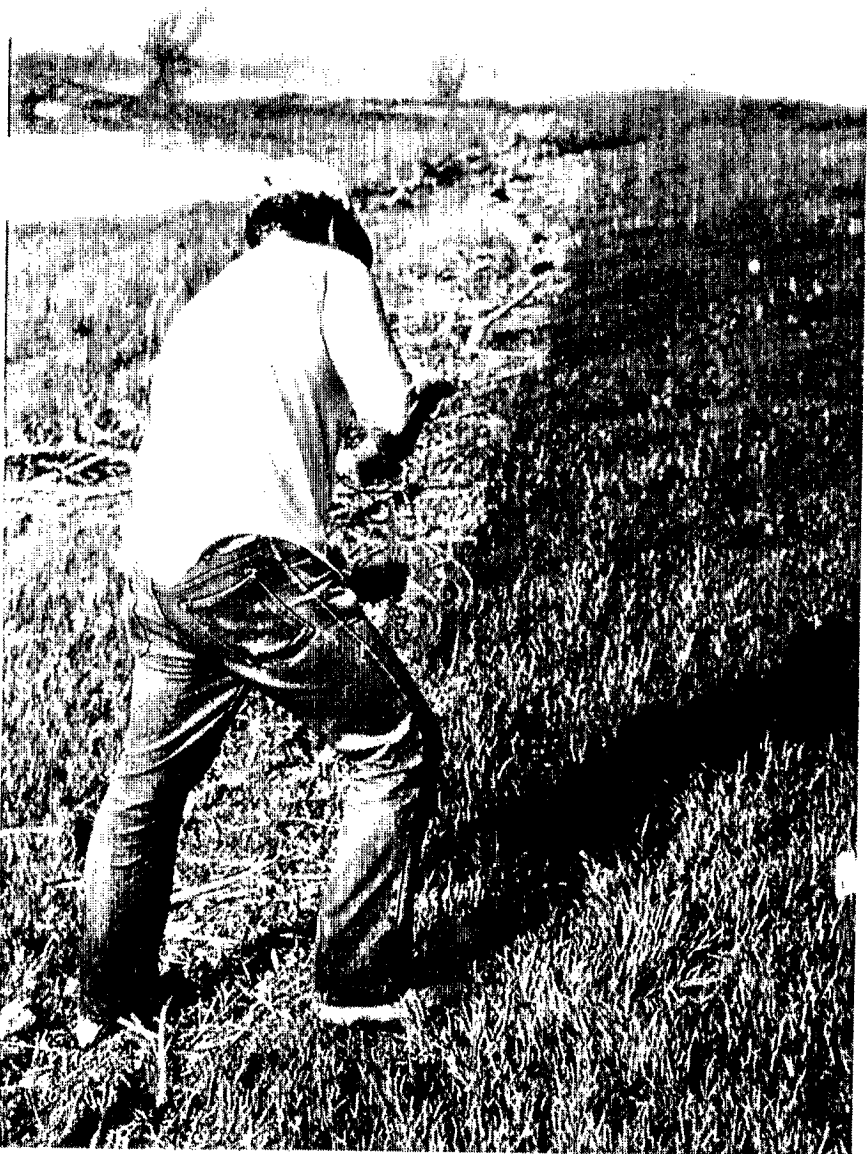
EMERGENCY FLOOD FIGHT EFFORTS IMPLEMENTED DURING FEBRUARY 1986 FLOOD.
 UPPER - FLOOD STAGES WERE WITHIN 1 FOOT OF LEVEE CREST, CACHE SLOUGH.
 LOWER - BOIL TRANSPORTING SAND, STEAMBOAT SLOUGH.
